# Spring mires fed by hot artesian water in Kruger National Park, South Africa

## SUMMARY

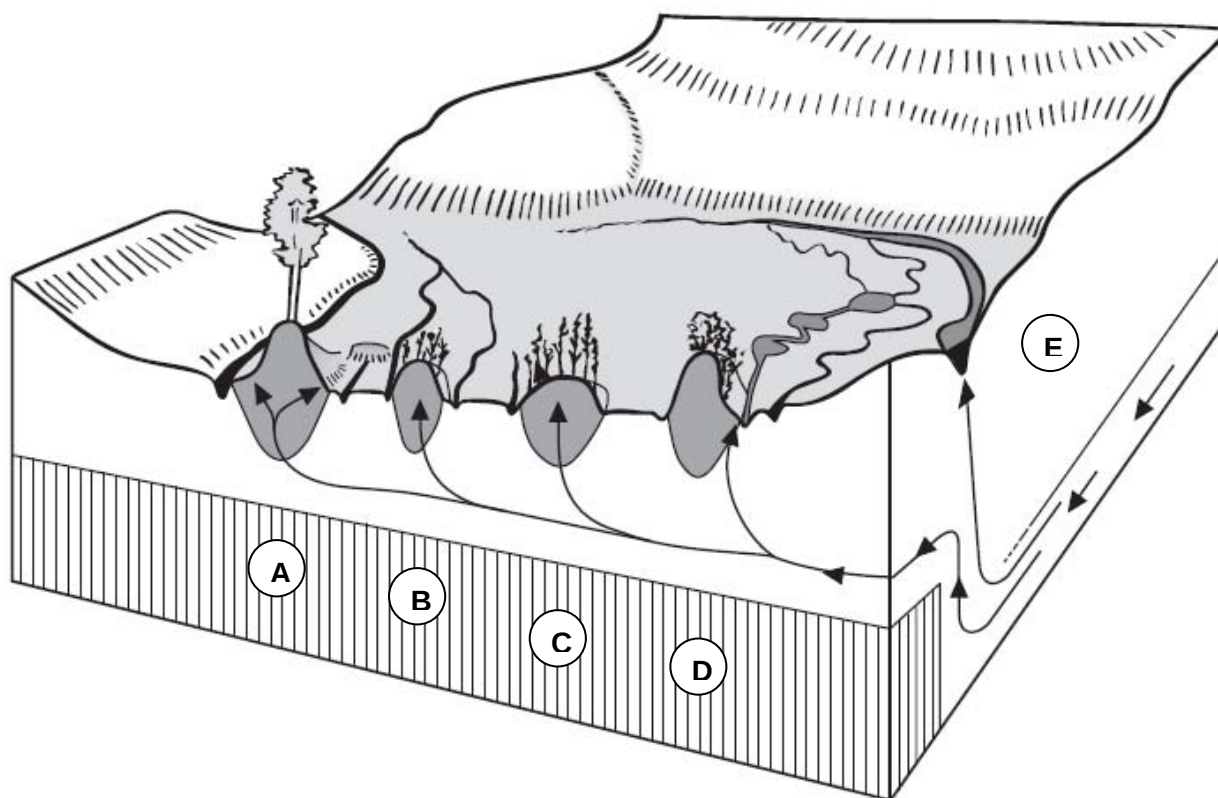
Figure 2. Schematic overview ('working model' *sensu* Grootjans *et al.* 2010) of the Malahlapanga wetland site showing four peat domes (A–D), as well as a mineral spring (E) that discharges warm groundwater (37°C) from a deep aquifer.

At Malahlapanga, several thermal spring mires were present within an area of 4–6 hectares (Figures 2 and 5). The most spectacular view was of three small (ca. 200–500m<sup>2</sup>) peat cupolas rising 1–2 m above their surroundings. Smaller wetland patches (1–10 m<sup>2</sup>) were present between the larger mires. These were sparsely vegetated and damaged by animals such as elephant, rhinoceros and buffalo that had trampled the peat in order to get to the water. The tops of the two largest cupolas (A and C in Figure 5) were apparently dry and lacked wetland vegetation, which was present only at the bases of these domes. Two smaller and wetter cupolas lying between the two dried-out domes had many wetland species across their entire surfaces.

Peat coring in the largest cupola (A) showed that the total peat depth was approximately four metres, of which one metre lay below the level of the surrounding plateau. This cupola was covered by grasses and tall herbs with some large trees, and its edges were severely damaged by wild animal trampling. Although it had dried out considerably and a tree (*Acacia grandicornuta*) had established at the dry outer edge (Figures 3 and 5), some typical wetland species such as *Phragmites australis* and *Bolboschoenus maritimus* were still present but with low cover. Wetland vegetation occurred only at the base of the dome and along the eroding rivulets that transported spring water out of the wetland. The temperature of the water escaping from the base of the dome was *ca.* 33°C, but after a few hundred metres dropped to 23°C. Thus, it appeared that this dome was no longer fed by groundwater.

The cupola (D) on the right in Figure 2 was less damaged by animals but again there were no wetland species on its summit. It was covered by shrubs and grasses, with wetland species growing only around its base (Figure 5). A temperature profile to a depth of two metres showed that the warm water escaped at the base of the dome and did not reach the surface of the mire (Figure 6). On the other hand, a temperature profile in one of the two small and wet mires (C) showed that warm water rose to a height of 0.4 m below the top of the dome, although temperatures in the main rooting zone were close to air temperature. Species of healthy wetlands including *Thelypteris confluenta*, *Leptochloa fusca* and *Bolboschoenus maritimus* were present in the cupola vegetation, indicating active wetland processes (Figure 4).

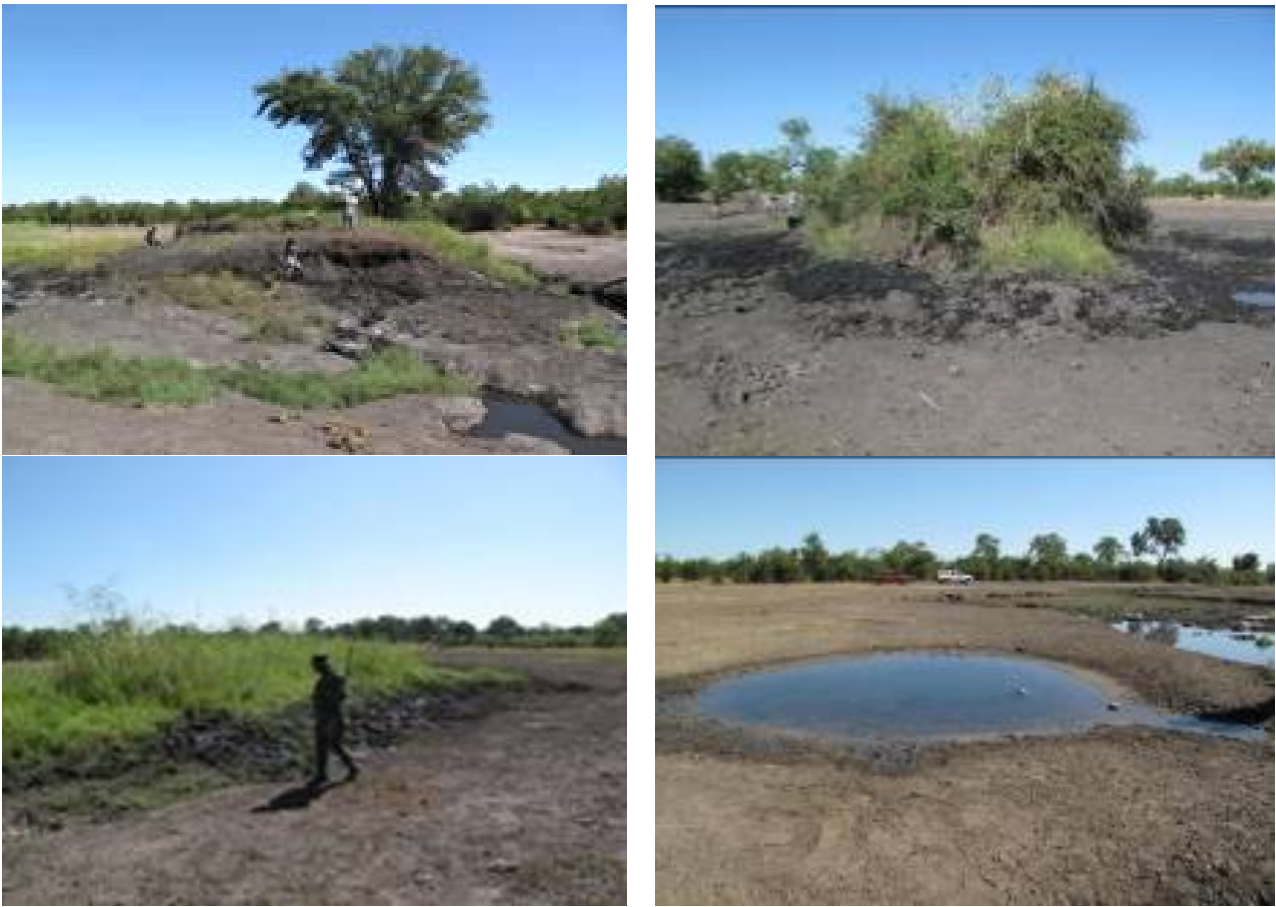
Figure 5. Severely eroded peat cupolas in the Malahlapanga spring mire complex with trees (top left, A in Figure 2) or shrubs (top right, D in Figure 2) on their summits. A smaller peat dome (bottom left, C in Figure 2) is much wetter and covered with typical wetland species. The small pool (bottom right, E in Figure 2) is a spring that discharges groundwater at 37°C from a deep aquifer.

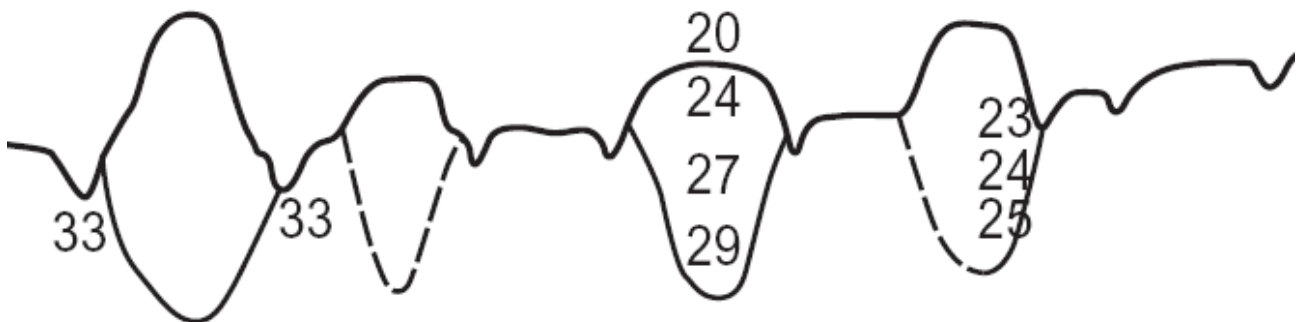
Figure 6. Temperature profiles in Malahlapanga for the two dried-out peat cupolas A (left) and D (right) and one cupola (C) whose summit is still wet (centre right). In Cupola C, warm water is rising higher in the profile than in the dry cupolas. Warm water is escaping at the base of the left-hand mire (A).

The temperature profiles (Figure 6) indeed suggest that the upward flow of groundwater in the two largest peat domes has been blocked, forcing the water to escape sideways.

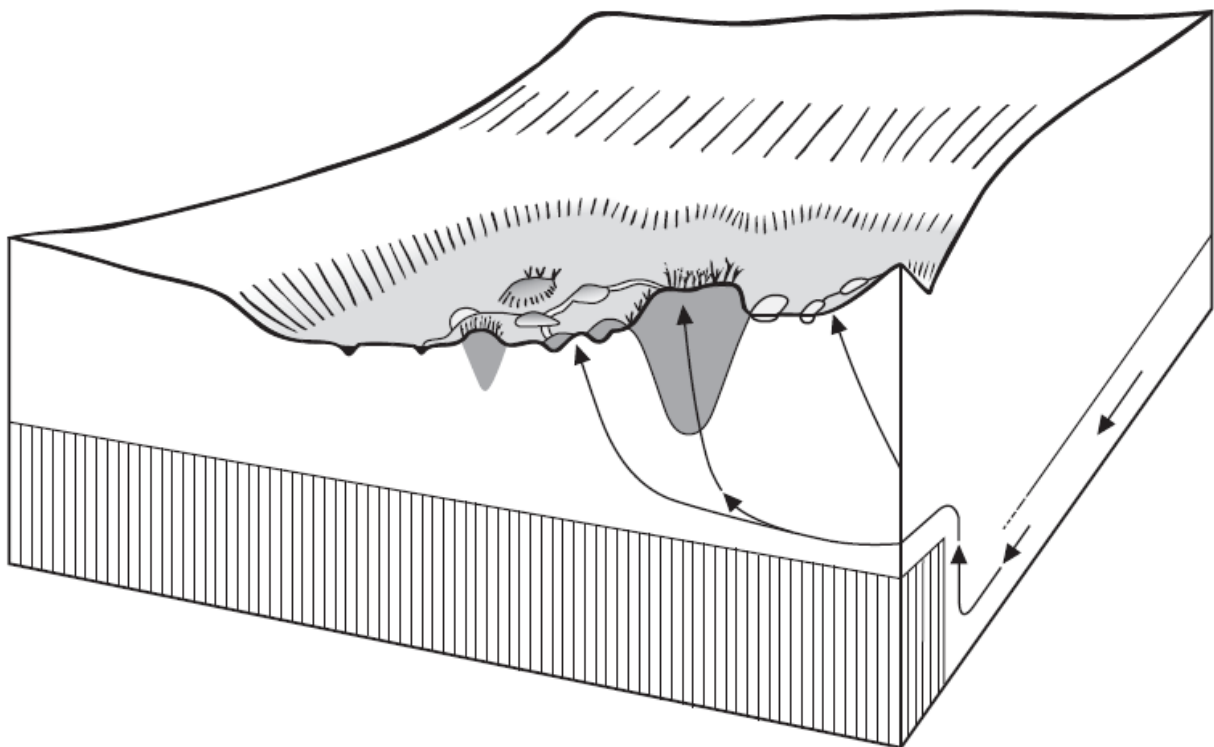
Figure 7. Schematic overview of the Mfayeni wetland site showing two small desiccated cupolas and one large and rather undisturbed cupola where warm groundwater (*ca.* 40°C) discharged into the rooting zone of

the vegetation.

The Mfayeni spring mire consisted of one large and little-disturbed cupola plus a few smaller highly mineralised and desiccated domes (Figures 7 and 9). Two of the smaller cupolas had some wetland species, but no wetland species remained on the driest one. We were unable to penetrate the dry cupolas with peat corers or the temperature probe.

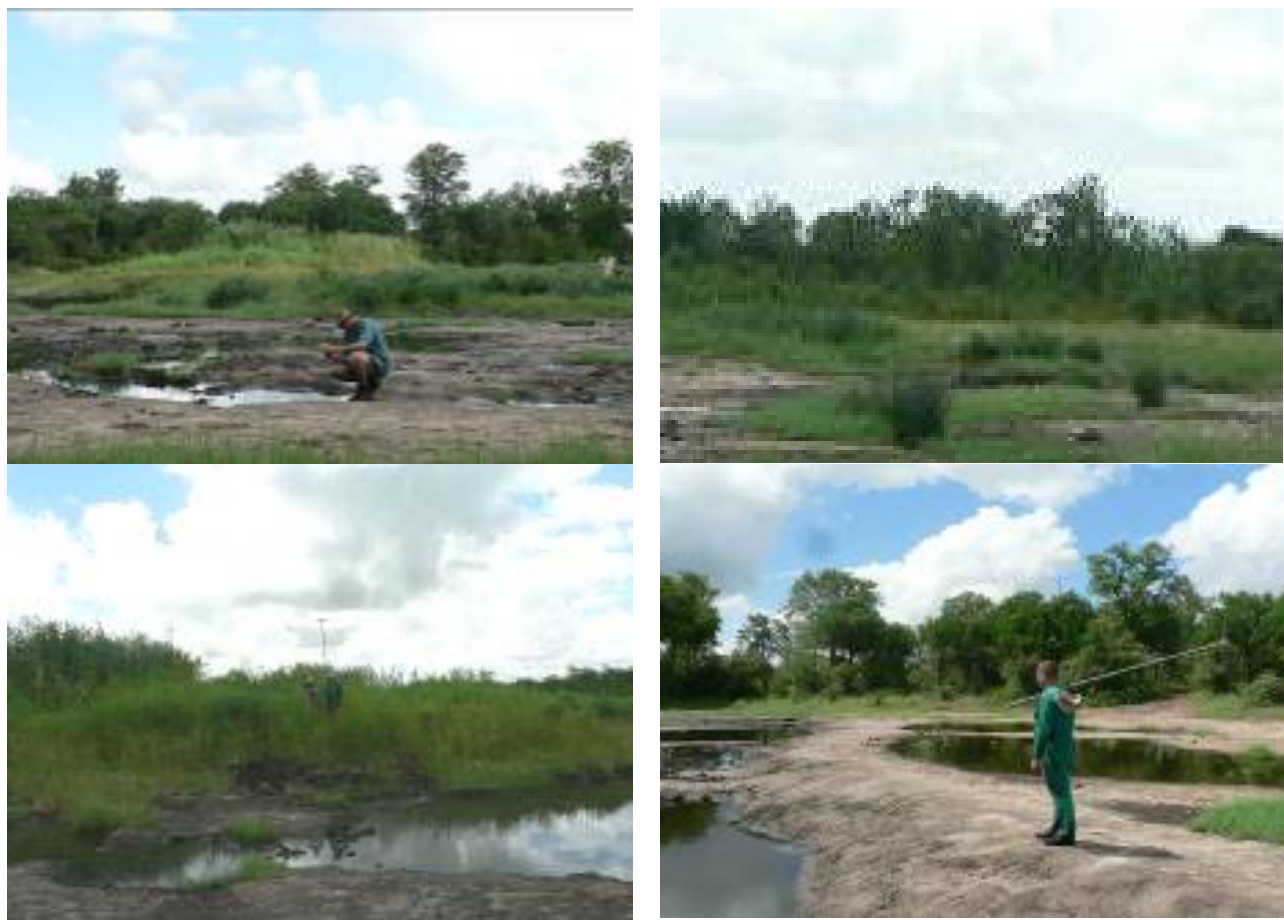
Figure 9. The large undisturbed cupola (top left) and the smaller highly mineralised cupolas (top right) at Mfayeni. The large peat dome is very wet and covered with typical wetland species (bottom left). The pools (bottom right) between cupolas and at the southern edge of the wetland are used by animals for water.

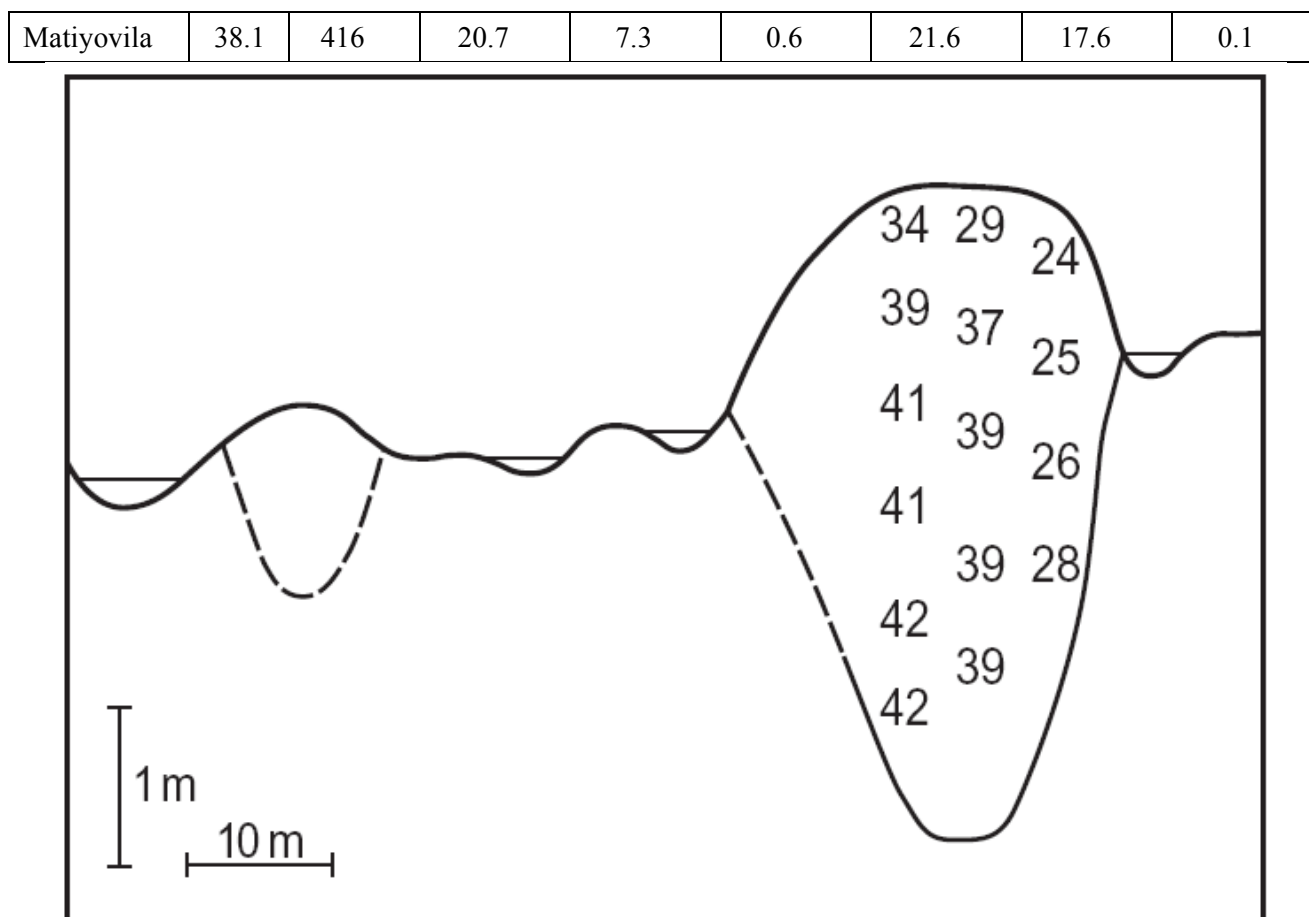
Figure 10. Temperature profiles (°C) in the large cupola in Mfayeni. Warm water was rising very high in the peat dome and cooled down only in the top 0.2 m. We were unable to investigate the dry cupola(s) shown on the left-hand side with the temperature probe, due to the high penetration resistance of the soil.

At the location where most of the groundwater discharged, the reed had formed a quaking mire. We measured three temperature profiles, starting in the main groundwater outflow and working towards the edge of the cupola. In the main spring the temperature increased from 34.5°C at the surface to

42°C at a depth of 1.8 m (Figure 10). These measurements show clearly that warm groundwater was rising up to the surface at the centre of the mire and then cooling to 25–27°C, which was close to the air temperature, as it was discharged towards the edges of the mire.
